Air Leakage Test Report

Client's Name: Flood Flaps

Purpose of Test: Pressure Testing for Air Leakage Comparison of Flood Vents

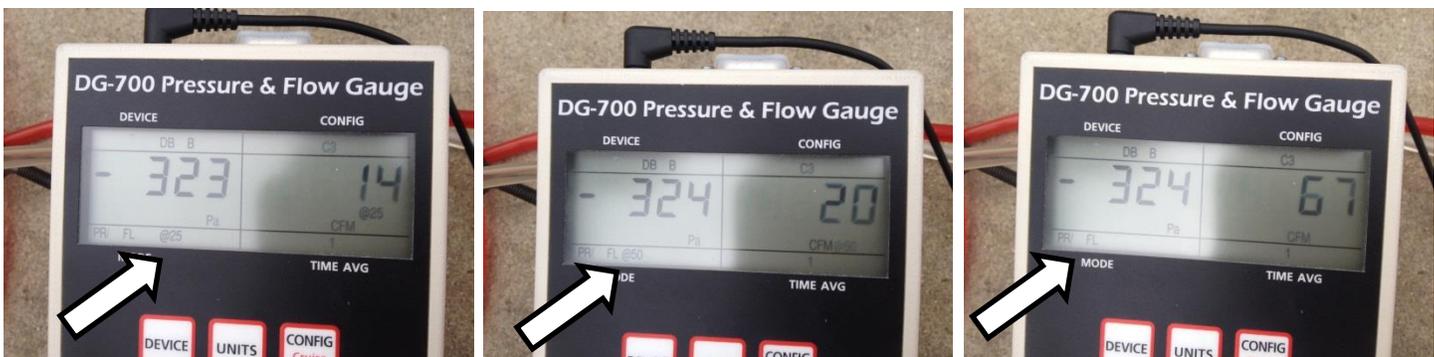
Photo above show the results from the Competitor's flood vent installed in the testing chamber.

The **photo above left** shows the adjusted leakage at 25 Pascals which was 14 CFM. (7 times Flood Flaps)

The **photo above middle** shows the adjusted leakage at 50 Pascals which was 20 CFM. (~7 times Flood Flaps)

The **photo above right** shows the leakage at 324 Pascals which was 67 CFM. (~7 times Flood Flaps)
